MEADOWLARK PROPERTY INSPECTIONS

Commercial Inspection Report

123 A St, Klamath Falls, OR 97603
Inspection prepared for: Silver LLC
Date of Inspection: 8/16/2024 Time: 9:00 AM
Age of Home: 1965 Size: 18679
Weather: Sunshine 61°

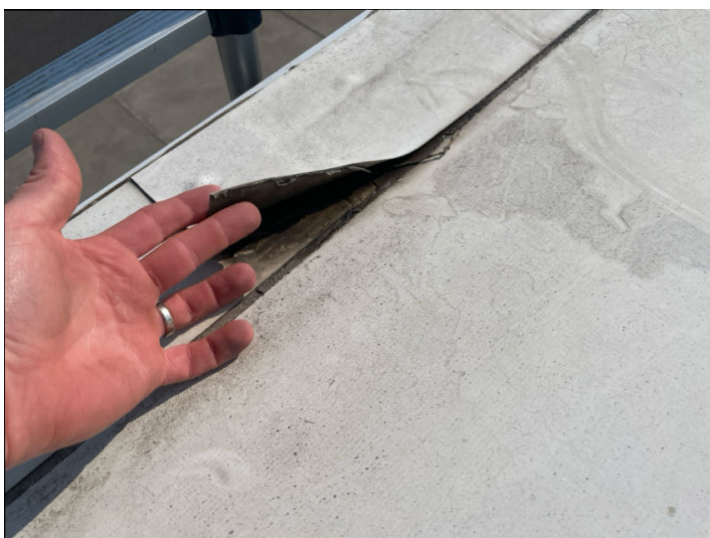
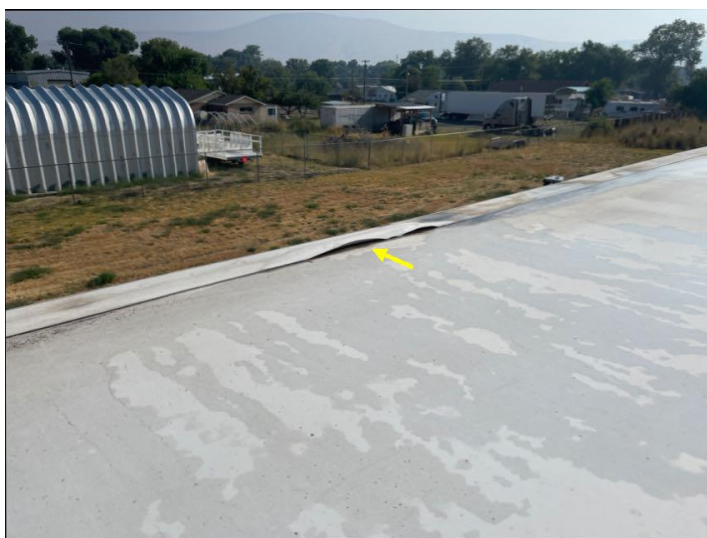
1. Roof Covering

6.5.1 Roof		
Page 7 Item: 1	Roof Covering	<ul style="list-style-type: none"> The IPO roof membrane was delaminated near the edge of the roof and needed resealing to prevent water intrusion. Corrections by a qualified licensed roofing contractor is recommended.

- No deficiencies were noted on the standing seam metal roof.
- The **TPO roof membrane** was delaminated near the edge of the roof and needed resealing to prevent water intrusion. Corrections by a qualified licensed roofing contractor is recommended.

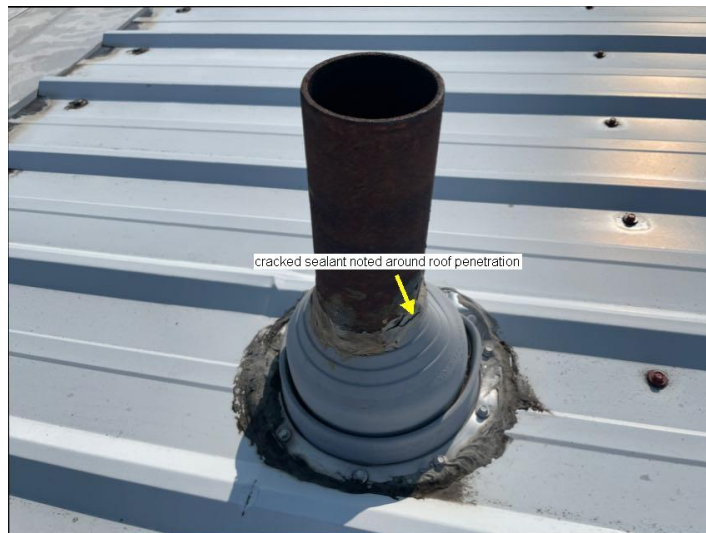
6. Vents, Flashings, Skylights, Chimney and other Roof Penetrations

- The flashings and roof penetrations appeared serviceable except where noted. Correction or modification decreases the probability of continued and excessive deterioration.
- Cracked sealant was noted around a plumbing vent cap on the roof. Re-sealing the plumbing vent caps is recommended.

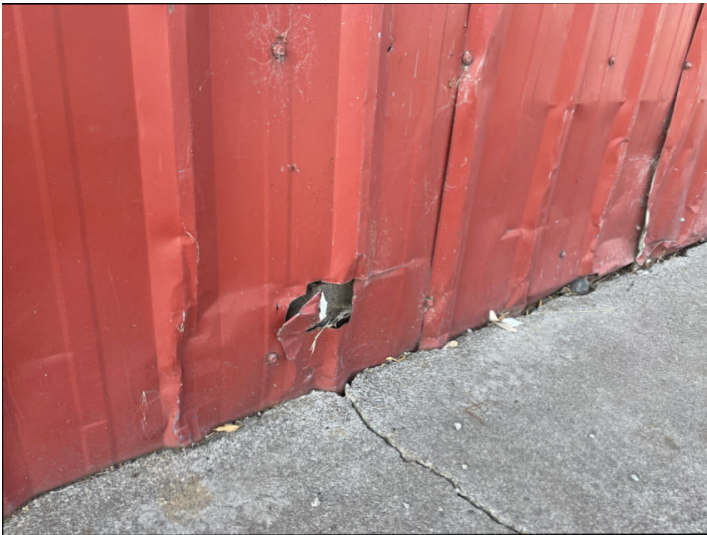
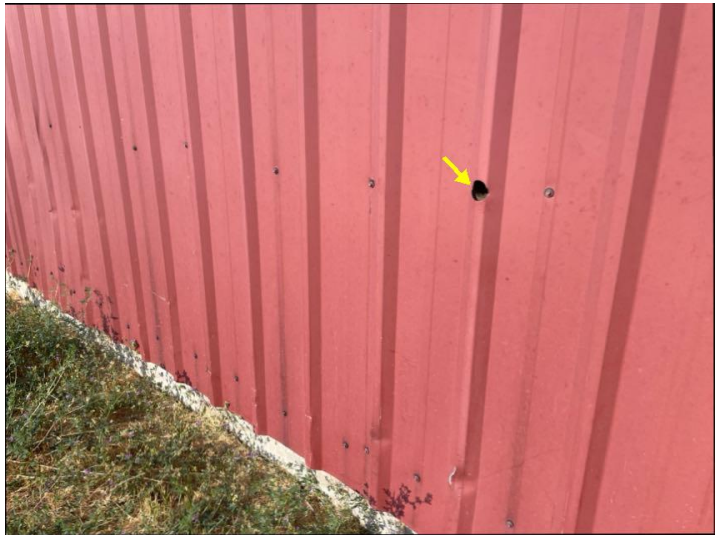
1. Siding, Flashing and Trim

- The siding and concrete block were in serviceable condition except where noted.

- Any holes in the metal siding should be sealed to prevent water damage and rodent access.

Correction or modification decreases the probability of continued and excessive deterioration.

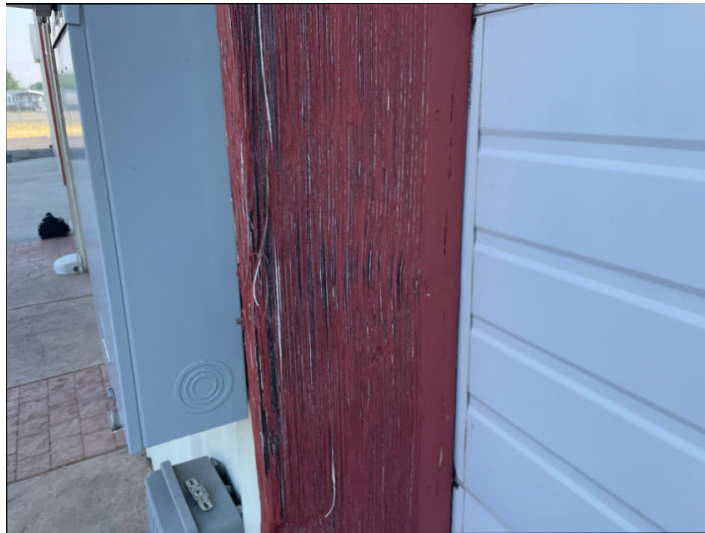
2. Doors, etc

- The exterior doors were in serviceable condition except where noted. Weatherstripping was installed and intact.
- The paint on the roll up doors was peeling and needed repainting to prevent deterioration. Correction or modification decreases the probability of continued and excessive deterioration.

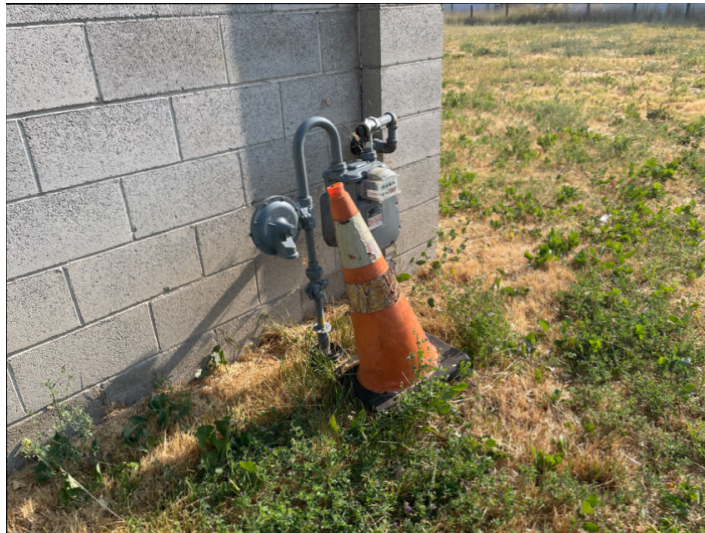
3. Safety Issues

6.5.2 Exterior		
Page 10 Item: 3	Safety Issues	<ul style="list-style-type: none"> A protective ballard should be installed at the gas meter to prevent damage from vehicles or mowers. Modification or addition is generally considered an upgrade which should improve safety or efficiency.
Page 11 Item: 7	Storm Water Drainage System	<ul style="list-style-type: none"> The storm drain at the front parking lot was full of water and not draining. Clearing the drain was needed. Corrections by a qualified licensed plumbing contractor is recommended. Repair, alteration or replacement usually improves the efficiency of the component or system.

- A protective ballard should be installed at the gas meter to prevent damage from vehicles or mowers. Modification or addition is generally considered an upgrade which should improve safety or efficiency.

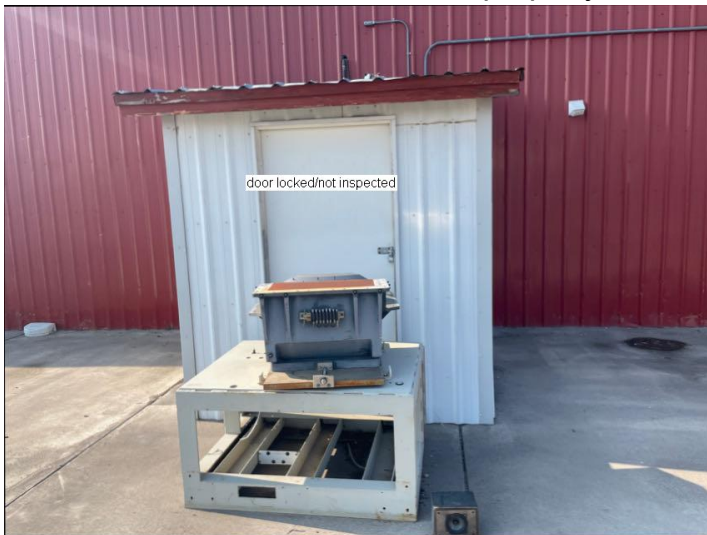
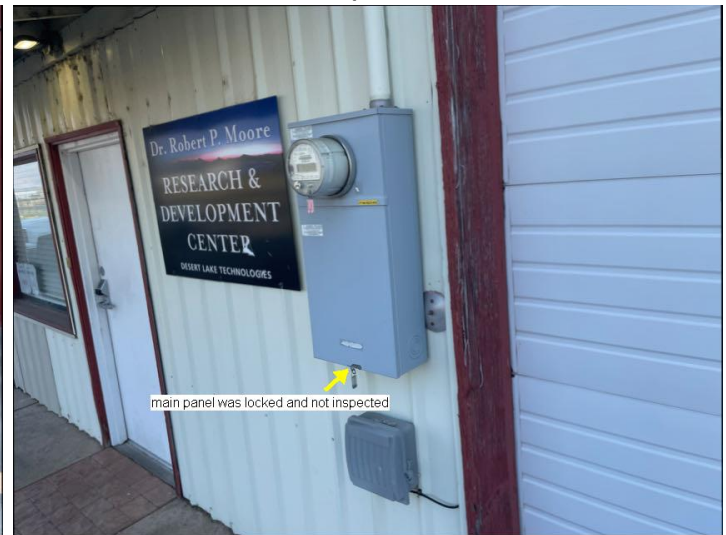
- The shed on the left side of the property was locked. The main electrical panel was locked.

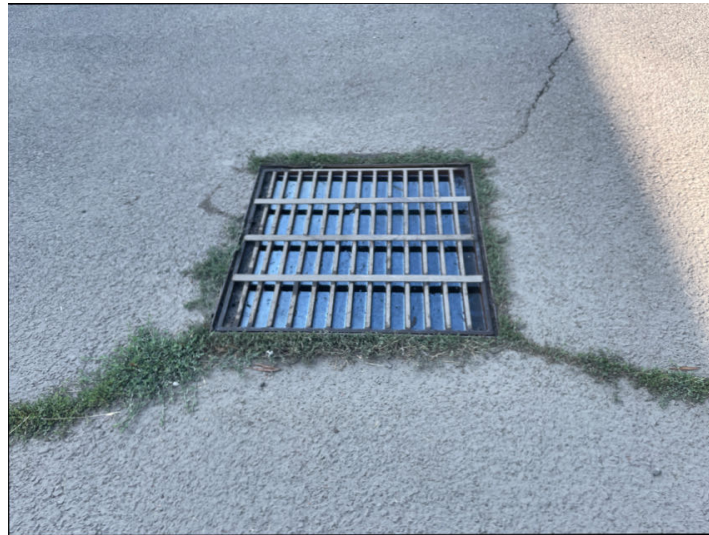
7. Storm Water Drainage System

- Storm drains are not tested during a property inspection.
- The storm drain at the front parking lot was full of water and not draining. Clearing the drain was needed. Corrections by a qualified licensed plumbing contractor is recommended. Repair, alteration or replacement usually improves the efficiency of the component or system.

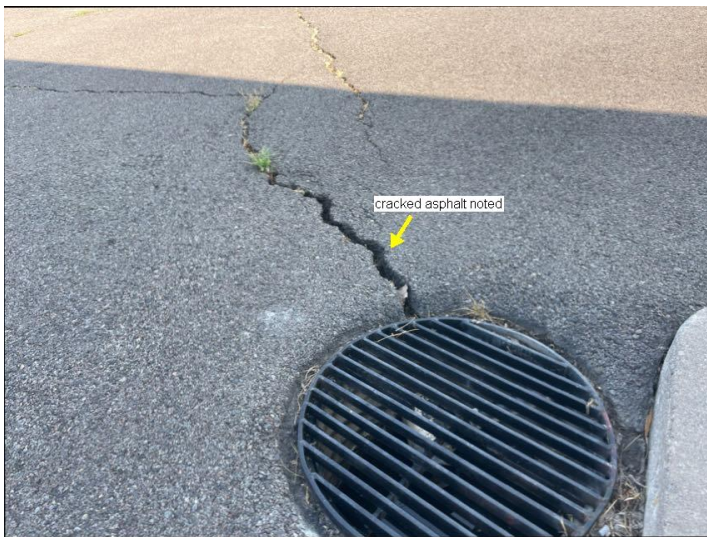
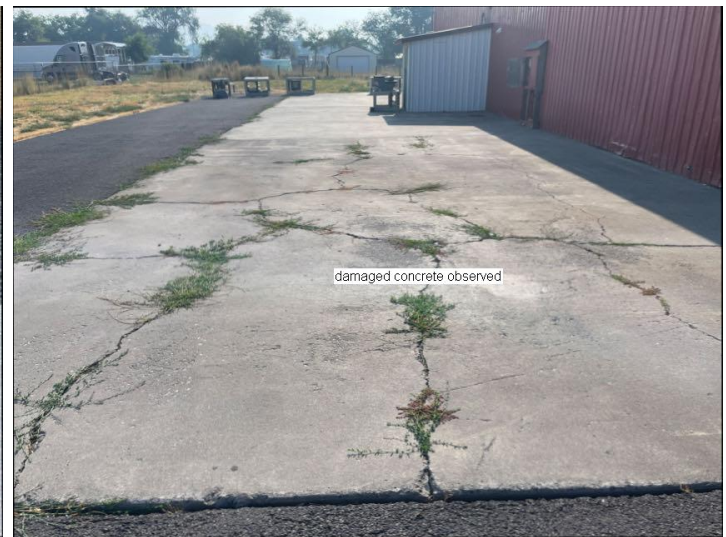
- Typical cracking was observed at the asphalt parking lot and the left side concrete pad. Further deterioration will occur as water seeps through and erodes the dirt underneath. Re-sealing the asphalt and concrete is recommended. Correction or modification decreases the probability of continued and excessive deterioration.

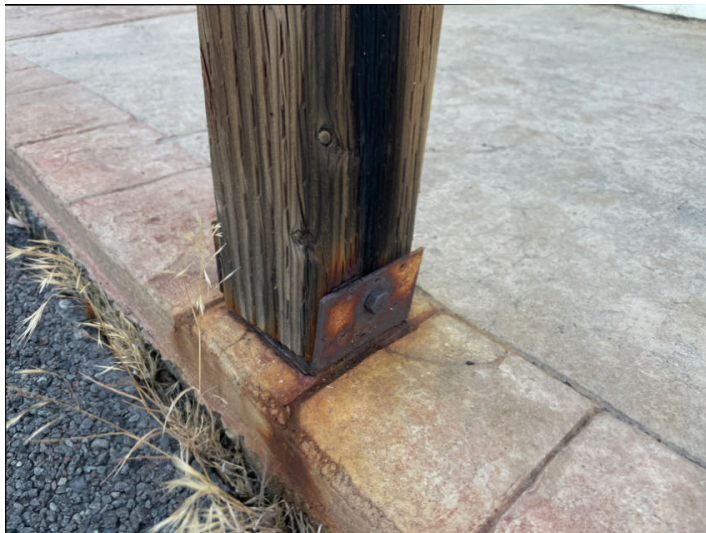
1. Fastener Rust, Iron Stain, And Corrosion

- The front entry porch support post brackets were rusted and will eventually need replacement. Repair, alteration or replacement usually improves the efficiency of the component or system.

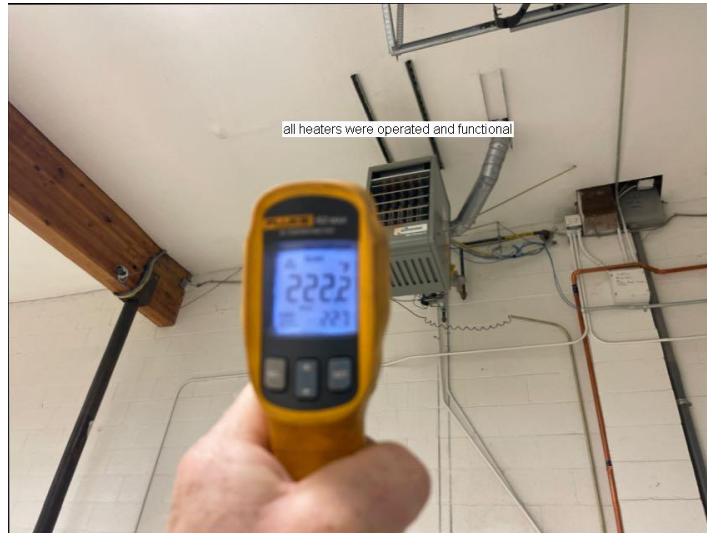
- The furnaces were functional from their thermostats during testing. Inspection from the ground level was noted.

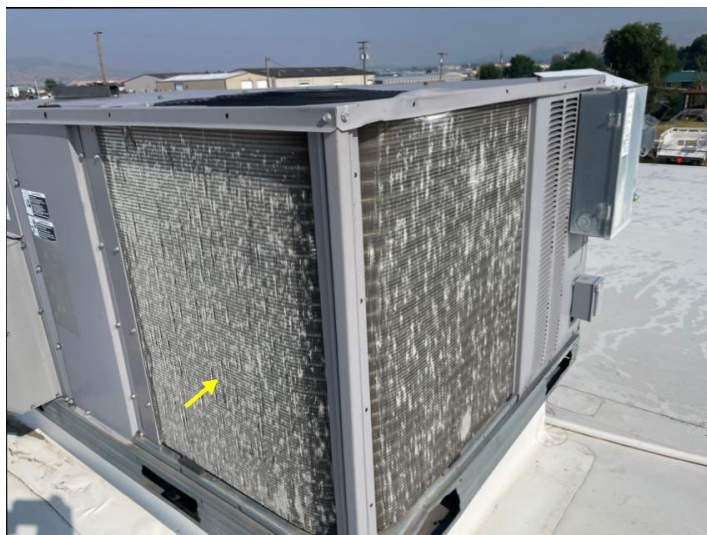
6.5.6 Cooling		
Page 17 Item: 1	Compressor Identification	<ul style="list-style-type: none"> The roof top unit (RTU) condenser was 17 years old and was approaching or past its serviceable lifespan. Typical lifespan of these units is approximately 15 years. The condenser fins were deteriorated and need to be in good condition to allow the proper airflow through the unit. Although functional during testing, replacement will be necessary in the near future.

- The roof top unit (RTU) condenser was 17 years old and was approaching or past its serviceable lifespan. Typical lifespan of these units is approximately 15 years. The condenser fins were deteriorated and need to be in good condition to allow the proper airflow through the unit. Although functional during testing, replacement will be necessary in the near future.

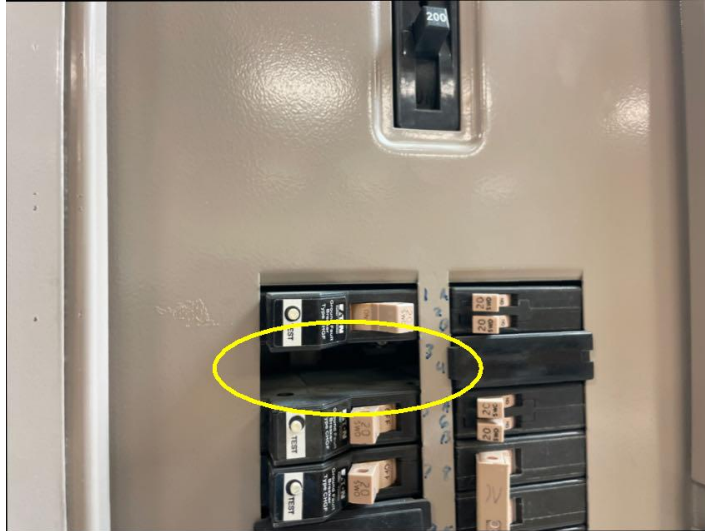
6.5.8 Electrical		
Page 22 Item: 6	Panel Openings	<ul style="list-style-type: none"> The electrical distribution panel D had an open knock out hole which needed the appropriate knock out seal to prevent a shock hazard. Corrections by a qualified licensed electrical contractor is recommended.
Page 23 Item: 11	GFCI	<ul style="list-style-type: none"> No GFCI was provided at the kitchen or bathrooms. Recommend upgrading All receptacles to GFCI protection within 6 feet of all potential wet locations. Modification or addition is generally considered an upgrade which should improve safety or efficiency. The opinion of a qualified licensed contractor is recommended.

- The electrical distribution panel D had an open knock out hole which needed the appropriate knock out seal to prevent a shock hazard. Corrections by a qualified licensed electrical contractor is recommended.

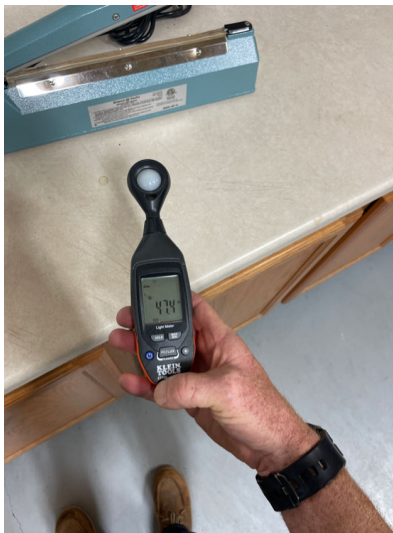
- The switches and lights were in serviceable condition.
- The illuminance was measured at 47 foot candles which is in the acceptable range for a commercial office.

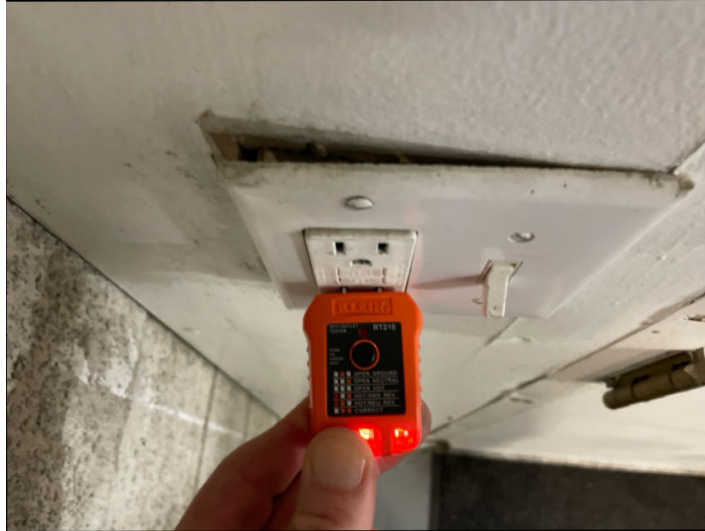
10. Outlets

- Accessible receptacles were tested and functional.
- A loose receptacle was observed by the left exterior door. All receptacle should be securely fastened to the wall. Modification or addition is generally considered an upgrade which should improve safety or efficiency.

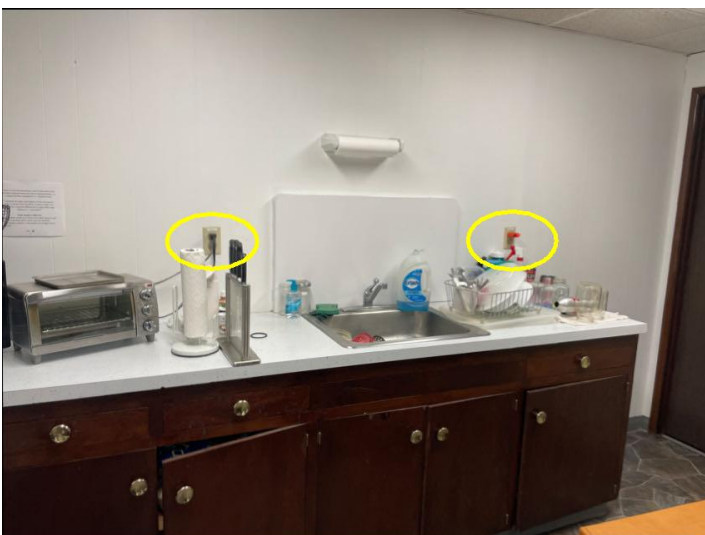
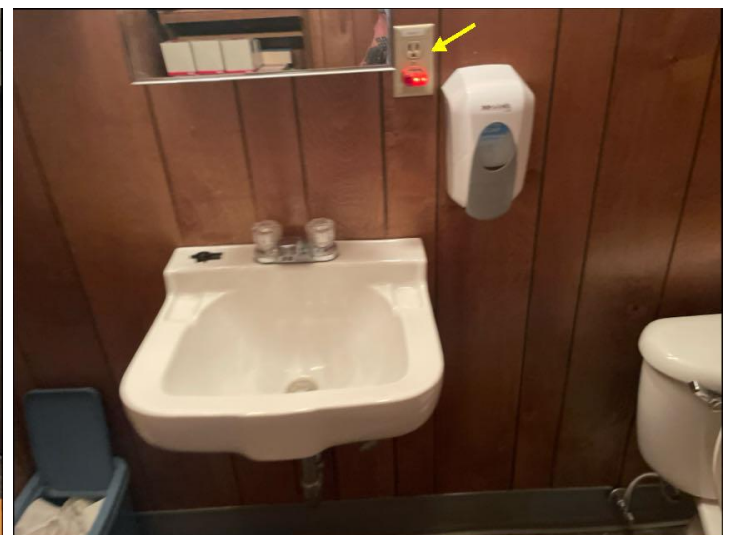
11. GFCI

- **GFCI** receptacles were noted in several areas.
- No GFCI was provided at the kitchen or bathrooms. Recommend upgrading All receptacles to GFCI protection within 6 feet of all potential wet locations. Modification or addition is generally considered an upgrade which should improve safety or efficiency. The opinion of a qualified licensed contractor is recommended.

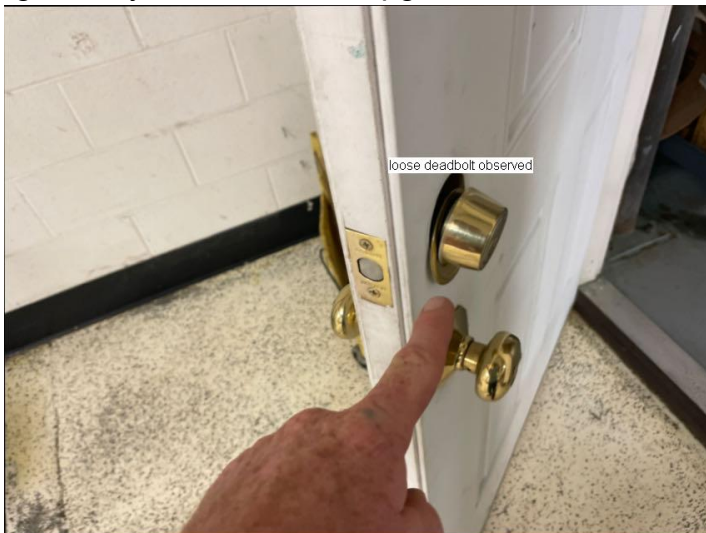
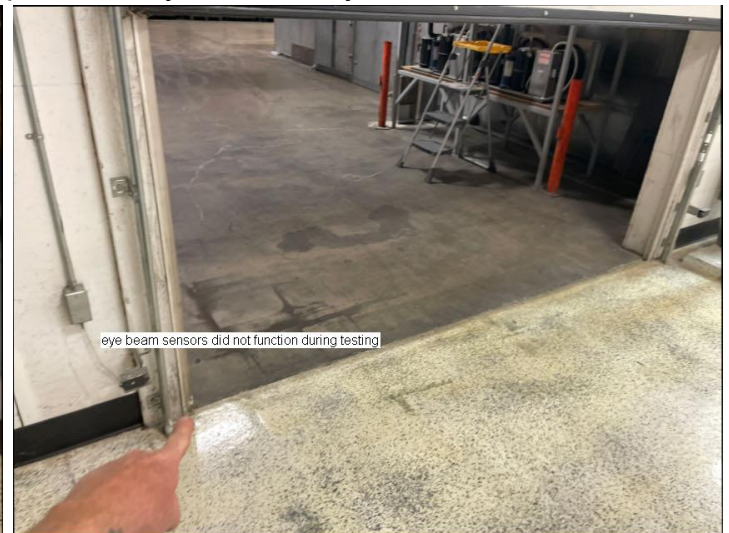
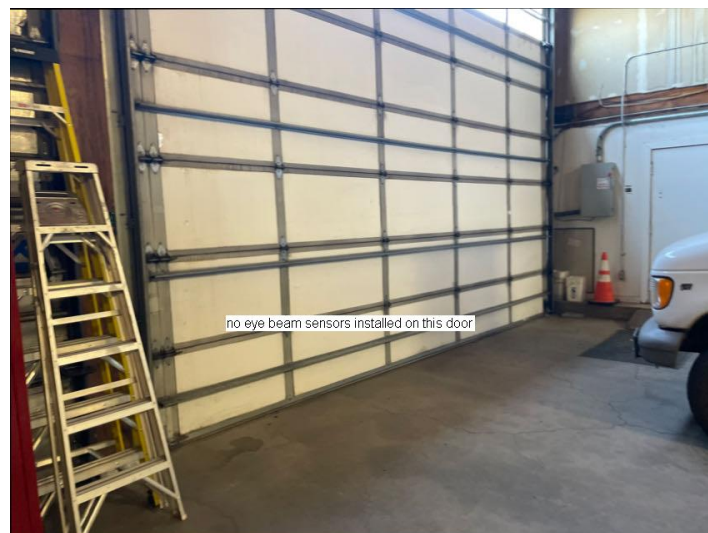
- The interior doors were in serviceable condition except where noted.
- No eye beam sensors were observed on the front exterior garage door. Caution is advised. The finding could be, or could become hazardous under certain circumstances.
- The eye beam sensors did not auto reverse the roll up door between the lab and warehouse during testing. Repair or replacement of the sensors is recommended. Modification or addition is generally considered an upgrade which should improve safety or efficiency.

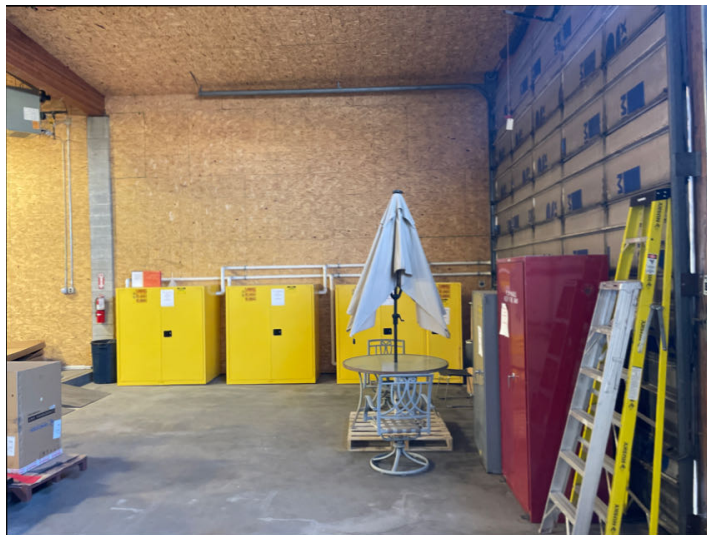
6.5.12 Life Safety		
Page 28 Item: 3	No Smoking Signage	<ul style="list-style-type: none">• A "No Smoking" sign was not posted in areas where flammable or combustible material was stored, dispensed, or used. Installation of a sign was needed in this area. Modification or addition is generally considered an upgrade which should improve safety or efficiency.
Page 28 Item: 5	Fire Extinguishers	<ul style="list-style-type: none">• 87 feet was measured between fire extinguishers in the main warehouse to the lab. Installation of an additional portable fire extinguisher was needed between these two. Modification or addition is generally considered an upgrade which should improve safety or efficiency.

- A "No Smoking" sign was posted at the front entryway.
- A "No Smoking" sign was not posted in areas where flammable or combustible material was stored, dispensed, or used. Installation of a sign was needed in this area. Modification or addition is generally considered an upgrade which should improve safety or efficiency.

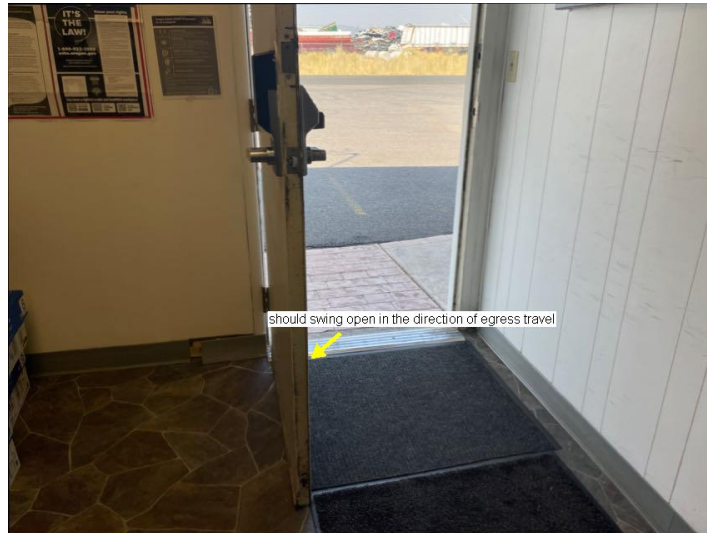
- The exit doors did not swing open in the direction of egress travel. Modification is generally considered an upgrade which should improve safety.
